Lake Seminole Restoration: Everything but the Kitchen Sink

Rob Burnes, MAS, MS

This article originally appeared in the Florida LAKEWATCH newsletter, Volume 75 (Dec. 2016)

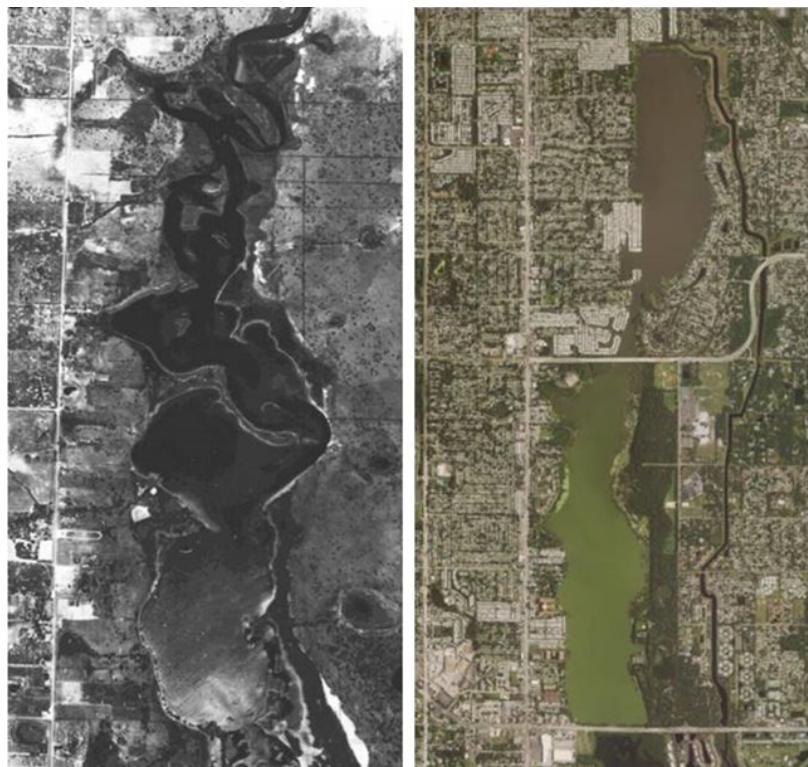
Figure 1. Lake Seminole prior to 1940's (Left) and Lake Seminole Present Day (Right)

Lake Seminole is a 685-acre hyper-eutrophic lake located in the west central portion of Pinellas County on the west coast of Florida, about 90 miles west of Orlando. It was created by impounding an arm of Long Bayou, a brackish water segment of Boca Ciega Bay that ultimately spills into the Gulf of Mexico. The creation of the lake was in conjunction with the planned construction of Park Boulevard by the State Public Roads Administration. There were quite a few reasons for the creation of Lake Seminole with the two major reasons being to provide irrigation of orange groves and as a potential potable water source. A fixed weir on the north end took flow into the lake from Long Creek and water flowed out of the system from a fixed weir on the south end of the lake (Figure 2). In the late 1970s, to alleviate upstream flooding

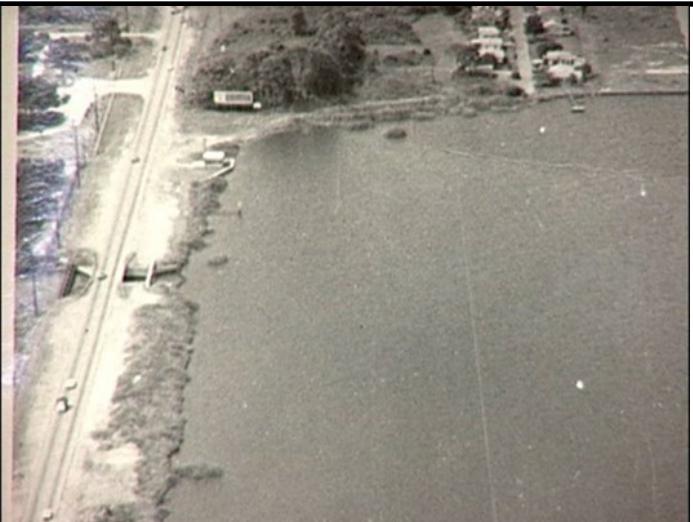
Figure 2. Lake Seminole Outfall during Construction of lake

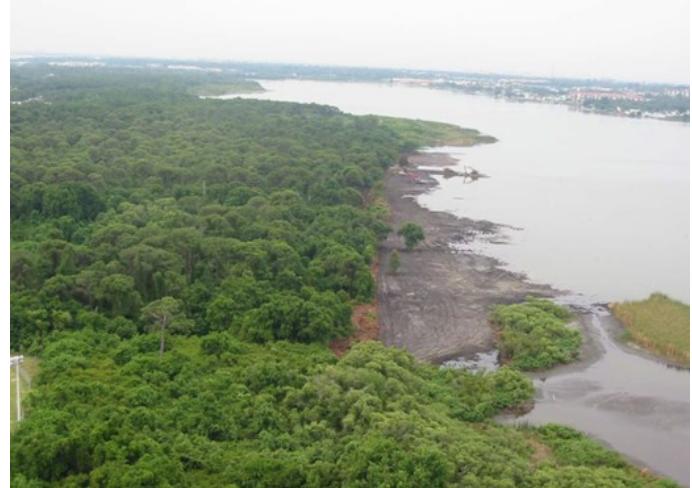
Figure 3. Lake drawdown for shoreline muck removal

To date, several projects listed in the RAP have been completed or are nearing completion. These projects focused on cleaning up the lake shoreline and placing lake-level instrumentation on the lake. The first project completed removed organic sediments from the littoral shelf in 2006 and was a continuation of a smaller-scale project of similar scope conducted by the Florida Fish and Wildlife Commission (FWC) in 2002. The work focused on removal of organic sediments from nearshore areas and tussocks. Approximately 130,000 cubic yards of organic sediments were removed, along with over 26 tons of garbage and debris (Figure 3). To visualize how much material was removed, the 130,000 cubic yards of material would create a 20-foot high pile of dirt over an entire football field, and the garbage and debris removed weighed as much as three elephants.

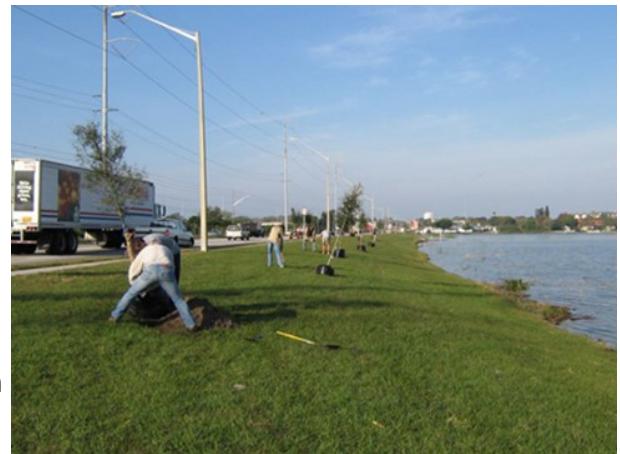
Figure 4. Upland revegetation after exotics removal

The next project to be undertaken was the restoration of priority wetland and upland habitats. The goal was to improve near-shore upland habitats through vegetation control. The main portions of this project were completed in 2008, though continued maintenance is still occurring on an as-needed basis. There were many areas targeted for restoration ranging from small strips of land adjacent to roadways that comprised no more than a few thousand linear feet to a large tract of wetland and upland several acres in size. The main upland species targeted were Brazilian Pepper (*Schinus terebinthifolius*) and air potato (*Dioscorea bulbifera*) and the main near-shore targeted species were cattail and willows (*Salix* sp.). The areas where nuisance vegetation was removed were immediately revegetated with native plants (Figure 4). These three projects helped to tackle the lake's issues but there was still much more work to do.

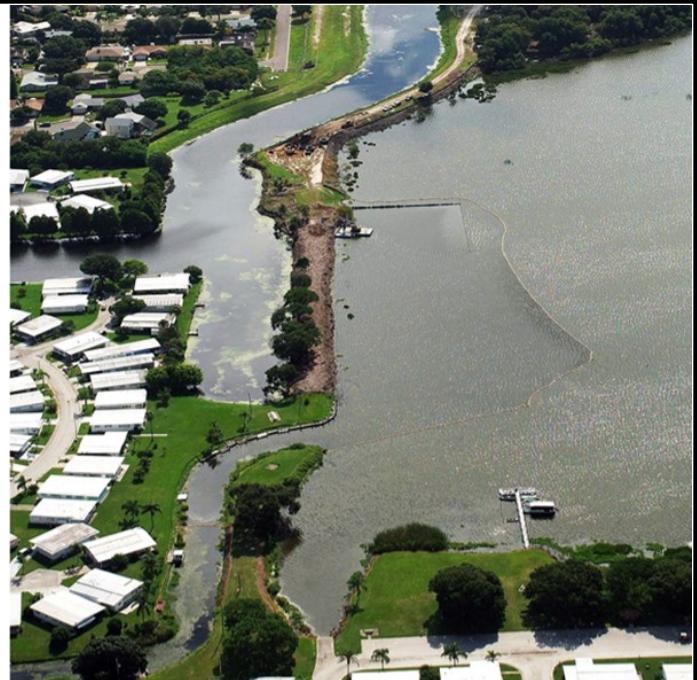
Figure 5. Alum facility on Lake Seminole during construction

The overall goal of the Stormwater Retrofit project is to reduce nutrient loads prior to entering the lake by injecting Alum (aluminum sulfate) into the stormwater which helps to sequester nutrients and sediments prior to entering the lake. Alum has long been used as a phosphorus removal tool in the wastewater treatment world and over the last 30 years it has gained acceptance as a tool to help remove nutrients and suspended sediments in surface water systems (lakes, streams, ponds, etc.). The process for treating the stormwater is relatively

simple. The systems were designed to release the Alum to only treat stormwater flow after it reaches a minimum assigned level for a certain period of time, thus ensuring the flow is storm-event driven. The rate of Alum release is based on flow, so as flow increases more Alum is released to adequately treat the stormwater. Based on preliminary testing, it is anticipated that removal rates will be upwards of 80% of the total phosphorus and total suspended solids in the stormwater. This reduction in nutrients and sediments will have a great impact on the health of the lake by reducing the annual nutrient load to the lake. This project will be completed and all of the systems will be operational by spring of 2017.
